**[REDACTED]**  
AERIAL PHOTOGRAPHIC INTERPRETATION REPORT

# PROBABLE SOLID PROPELLANTS TEST FACILITY AND ASSOCIATED PRODUCTION FACILITIES NEAR PERM, USSR

NATIONAL PHOTOGRAPHIC INTERPRETATION CENTER

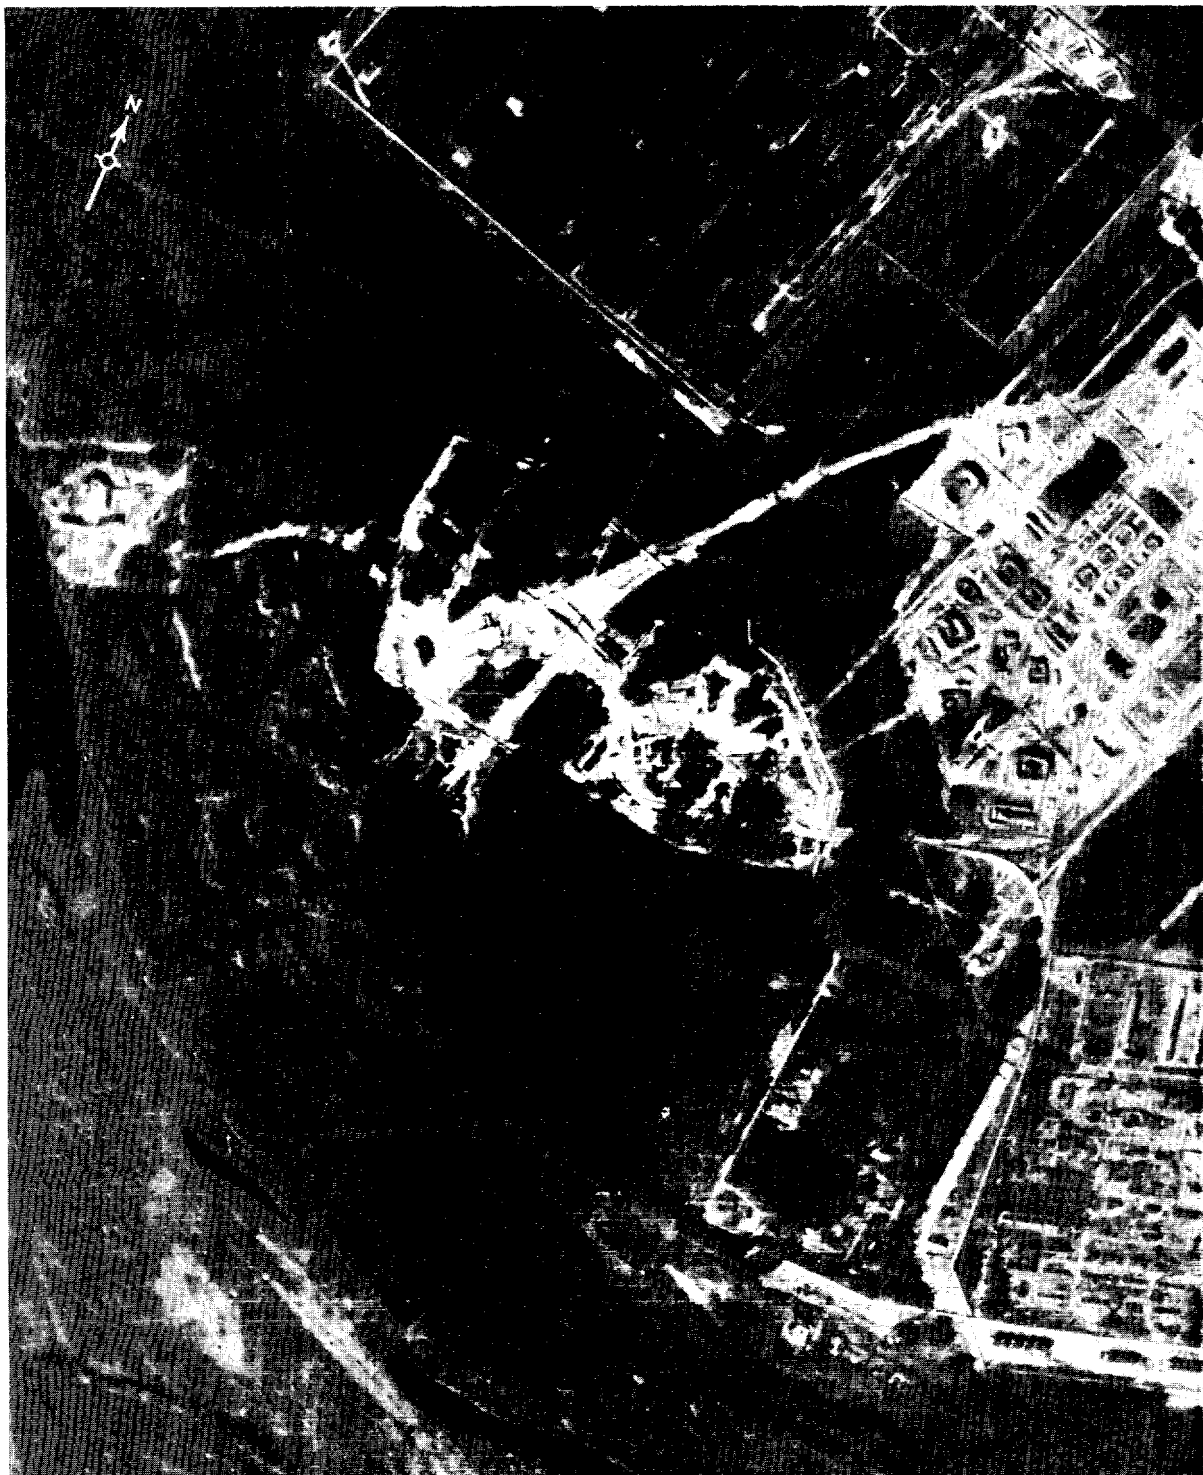
FIGURE 3. THE PROBABLE SOLID PROPELLANTS TEST FACILITY

The Perm Probable Solid Propellants Test Facility (Figures 3 and 4) occupies a walled area measuring approximately 4,500 by 1,700 feet and is rail served. It consists of the following structures: one test cell (item 1, Figure 4) and its associated blast deflector; an irregularly shaped building with 4 sections (item 5) which is a modified H-shaped building and probably serves the same purpose as the H-shaped buildings at Biysk, Krasnoyarsk, and Sterlitamak; a high-bay building (item 6), and three other major buildings (items 2, 3, and 4). A perspective drawing of the facility is shown on Figure 5.
